MOUSAM RIVER BASIN
SANFORD, MAINE

GOODALL-SANFORD DAM
ME-00185

PHASE I INSPECTION REPORT
NATIONAL DAM INSPECTION PROGRAM

JUNE 1979

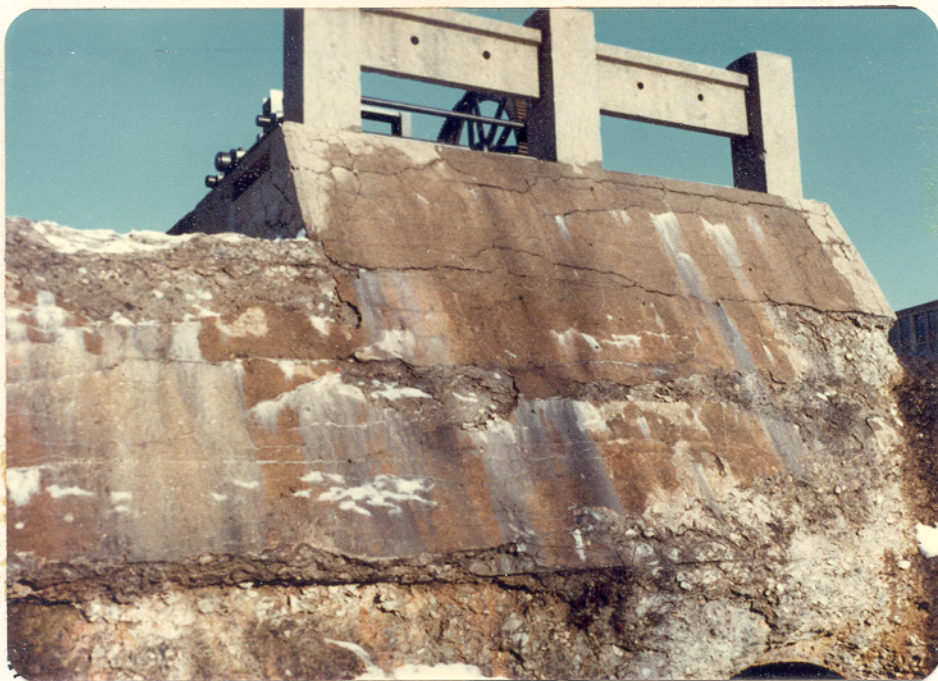
- d. Visual Observations. Water level at the Goodall-Sanford Dam can be regulated only by the gated outlet. The concrete of the gated outlet discharge channel is deteriorated (see photographs 1 and 2). The crest and downstream face of the spillway are in good condition. No significant scour was noted at the toe of the dam. Only about 2 feet of freeboard exists between normal water surface easterly of spillway crest and the top of the concrete dike walls along the east and west shores.

- (1) Deterioration of concrete in gated outlet and process water headworks (see photographs 1, 2, 4, and 5).
 - (2) Leakage from beneath the east wingwall below the dam.

- a. Concrete Surfaces. The concrete surfaces of the Goodall-Sanford Dam range from fair to very poor. Around the process water headworks and the gated outlet section of the dam, deep spalling has occurred (see photographs 1, 2, 4, and 5). At the process water headworks, the spalling has progressed to a point where reinforcing steel is exposed and the wingwalls of this section are considered to be in very poor condition. The surface of the spillway shows evidence of some erosion and minor spalling. In other areas of the dam, particularly the wingwalls, there is substantial cracking and substantial lime stain and some rust stain. The surficial cracking appears to be related to a lime silica reaction in the concrete.

OUTLET GATEWORKS

- (1) Repair the spalled and deteriorated concrete in the gated outlet and process water headworks.
- (2) Remove trees in downstream channel.
- (3) Repair or replace badly corroded gate stems.
- (4) Provide around-the-clock surveillance during periods of anticipated high runoff.
- (5) Develop a formal warning system and implement its use in the event of an emergency.
- (6) Have inspections of the dam made by qualified engineers once every year.

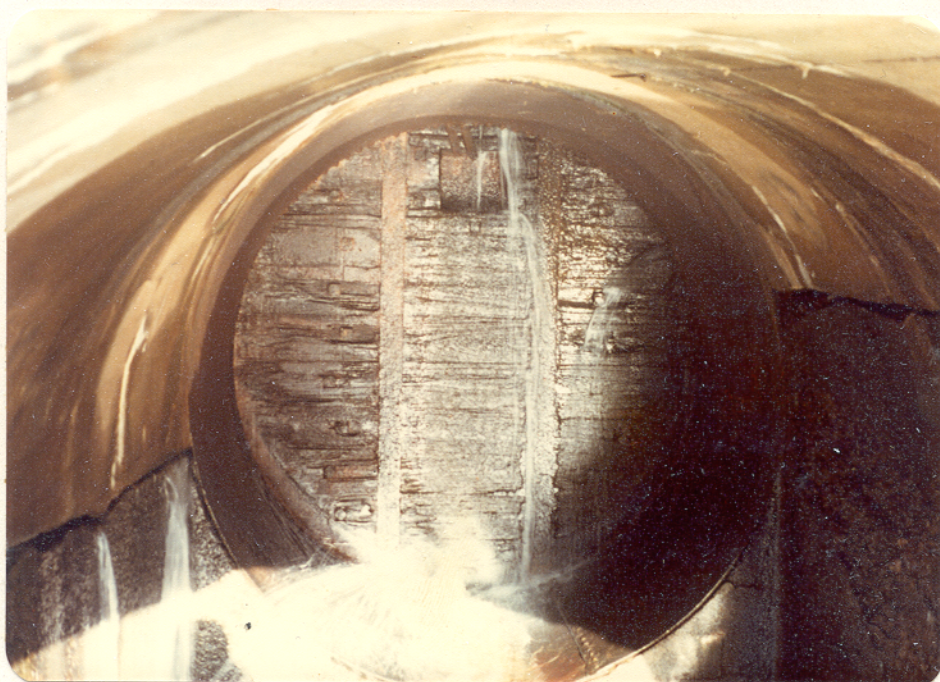
2

OUTLET GATE

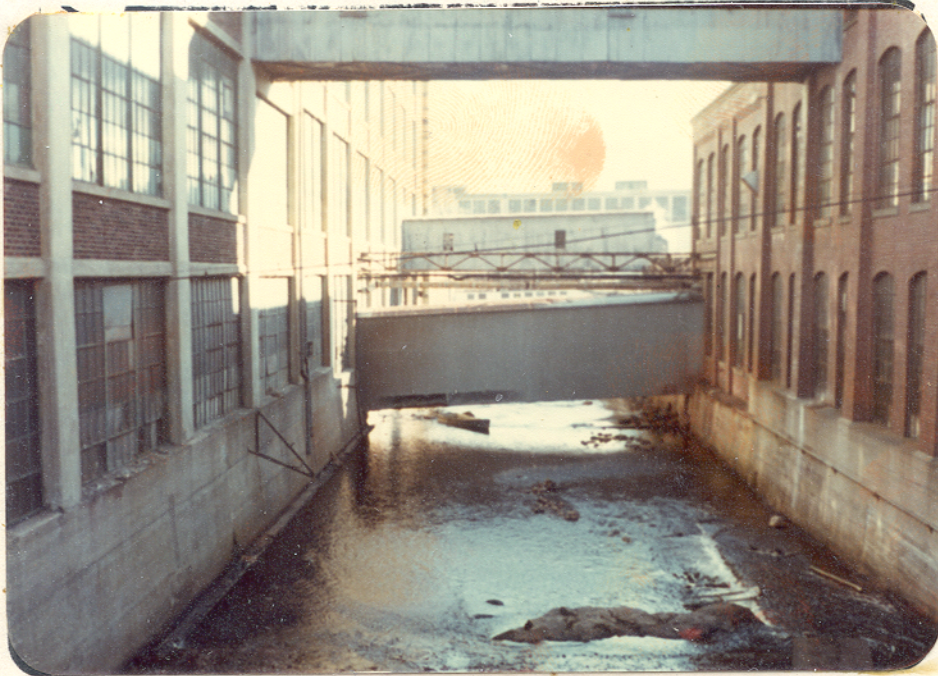
3

DOWNSTREAM CHANNEL RESTRICTION

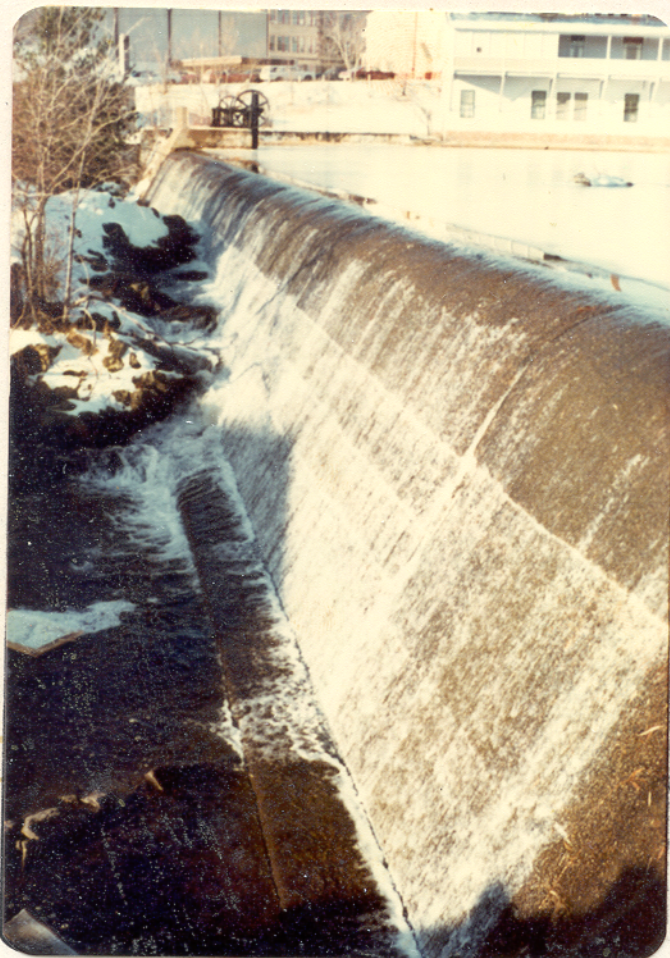
4

DOWNSTREAM FACE

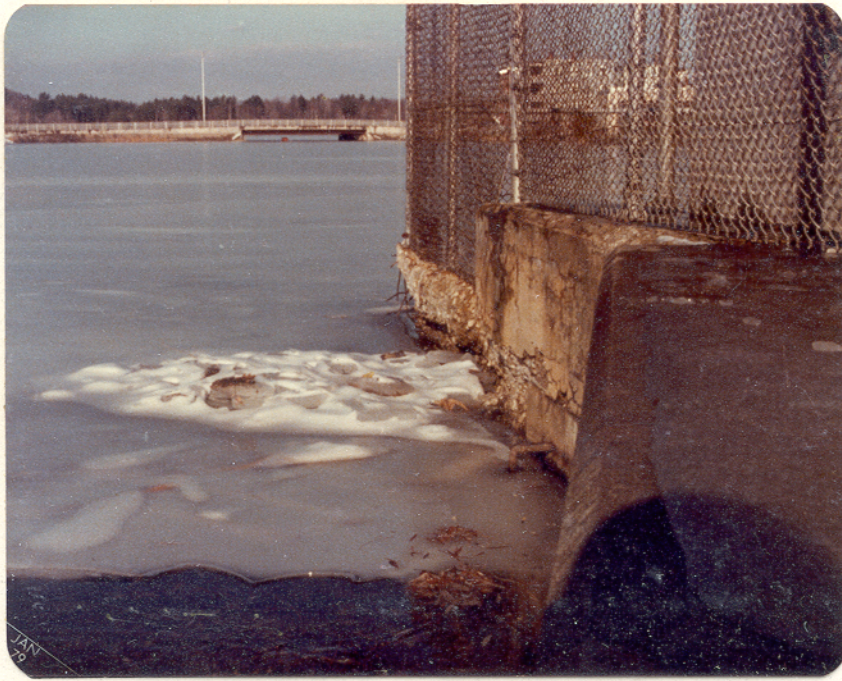
5

UPSTREAM VIEW

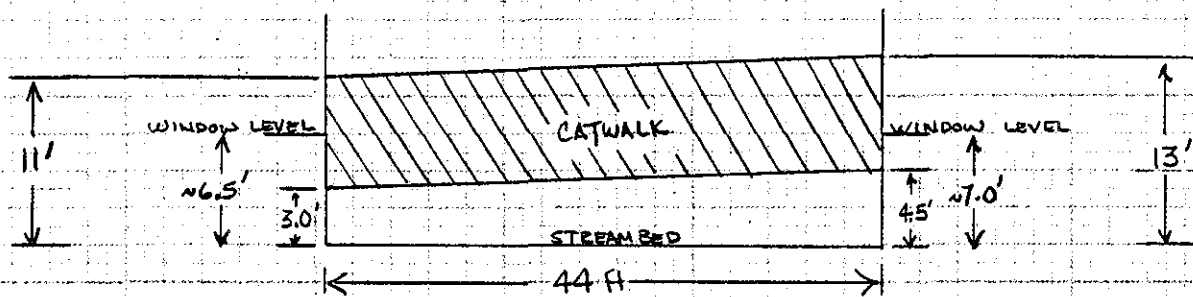
CROSS - SECTION #2 (AT CATWALK LOCATED ~ 250 FT BELOW DAM)

NOTE: CATWALK SIDES AND ROOF ARE CONSTRUCTED OF THIN SHEET METAL AND IS SUPPORTED BY 12" AND 8" STEEL "I" BEAMS. FLOOD WATERS IMPACTING THE CATWALK WOULD PROBABLY SEVERELY DAMAGE AND WASH OUT THE SHEET METAL PORTIONS OF THE STRUCTURE.

A qualified engineer should be engaged to develop provisions for curtailing leakage occurring through the east abutment and to make recommendations to eliminate or relocate the catwalks downstream of the dam.
